HOUSATONIC RIVER BASIN
LEE, MASSACHUSETTS

LAUREL LAKE DAM
MA 00263

PHASE I INSPECTION REPORT
NATIONAL DAM INSPECTION PROGRAM

FEBRUARY 1979

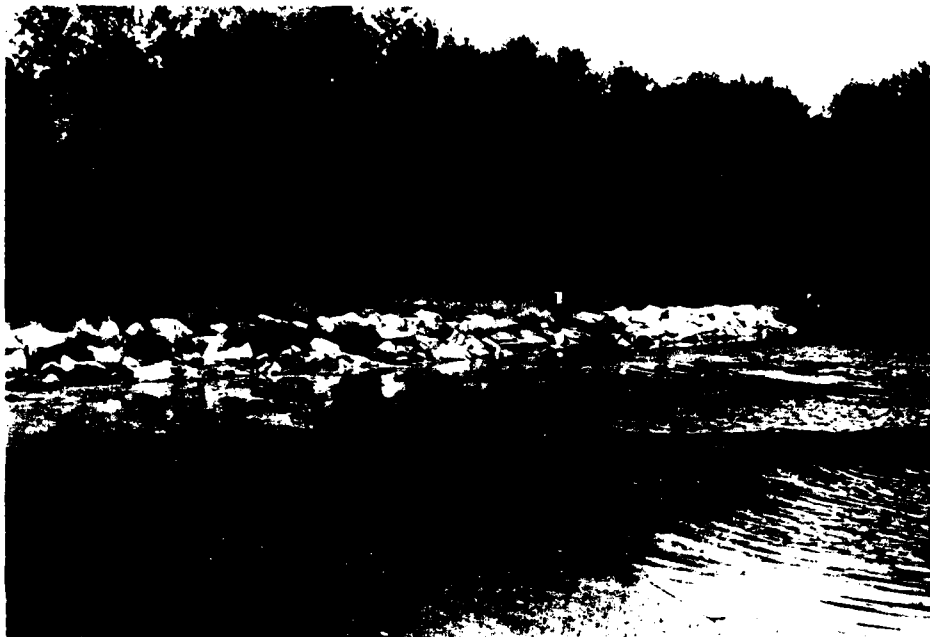
1. OVERVIEW OF UPSTREAM FACE OF DAM.

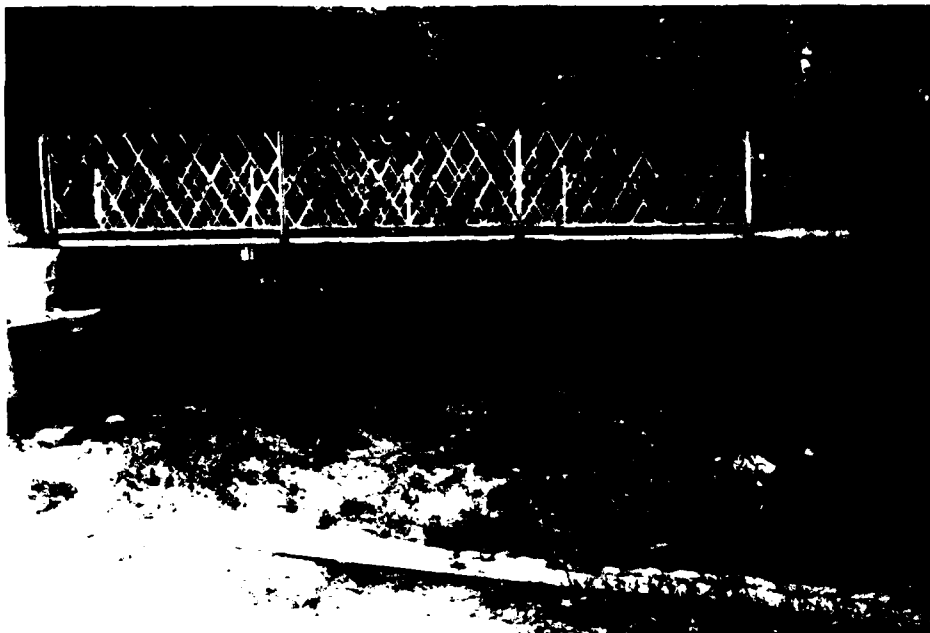
- c. Appurtenant Structures - The bridge over the spillway, as shown in Photo 12, is in good condition. The railing and bridge stringers are exhibiting areas of rust and need repainting. The concrete adjacent to the right bridge abutment bearings has cracked.

12. SPILLWAY APPROACH CHANNEL AND BRIDGE OVER SPILLWAY.

3. Remove brush and debris from the discharge channel and cut and remove overhanging trees.
 4. Provide maintenance on appurtenant structures including replacement or shuttering of windows and repainting of steel and wood at the spillway bridge, gatehouse and outlet work intake.

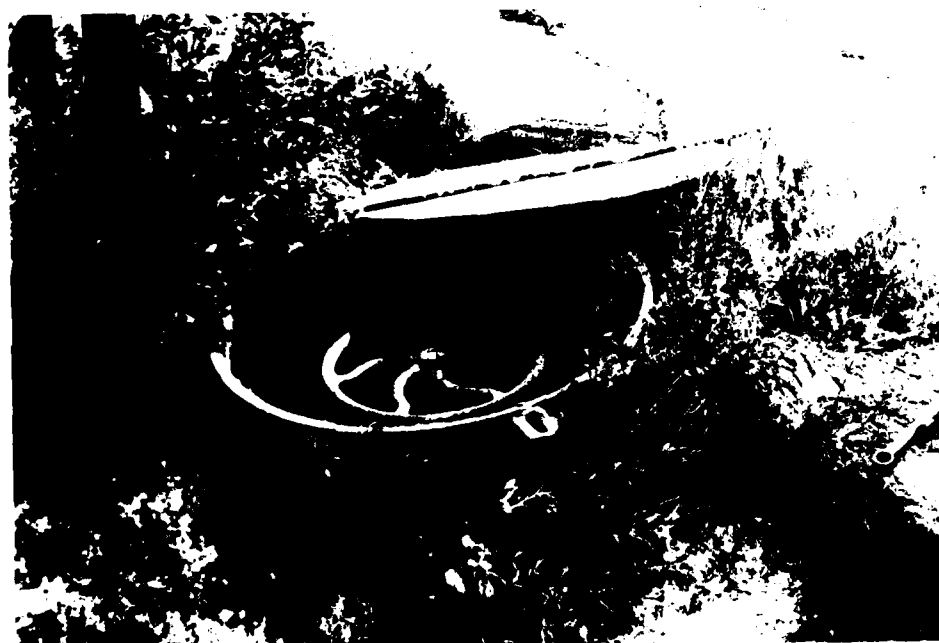
The outlet works inlet structure and control manhole shown in Photos 10 and 11, respectively, are in excellent to good condition with only minor rusting being noted on the metal work. Minor deterioration of the inlet structure concrete was also observed.

11. VALVE AT INLET STRUCTURE.

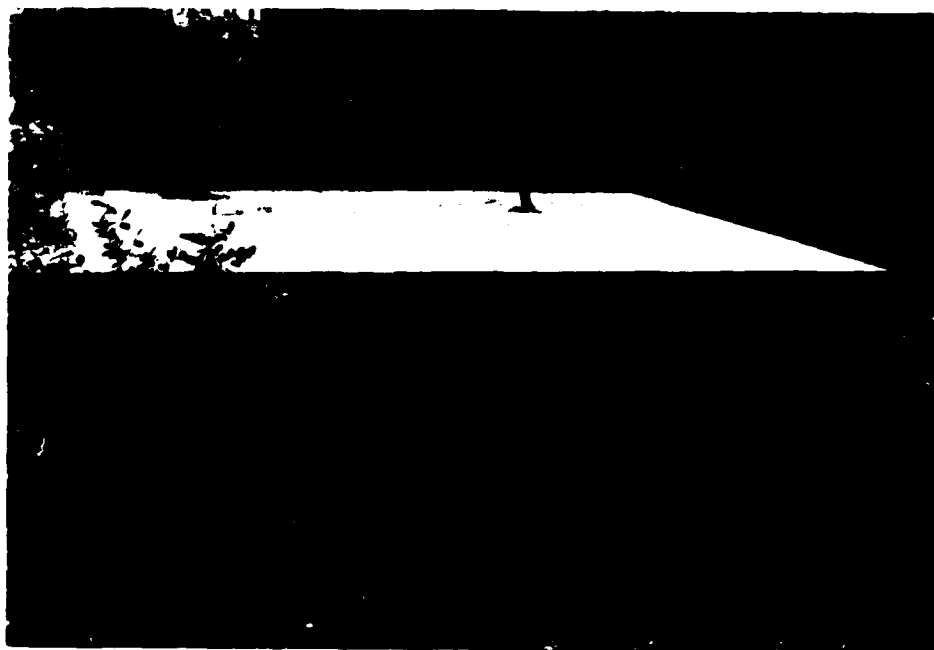
The downstream gatehouse shown in Photo 7 has essentially been abandoned. Windows are broken and debris and water are present on the floor. The door is in need of repainting.

7. GATEHOUSE.

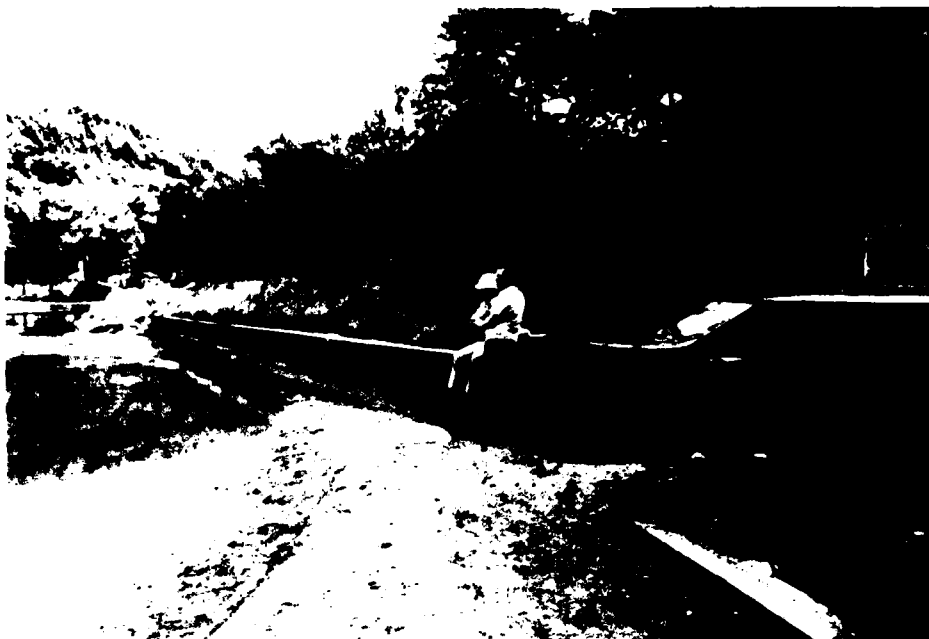
2. UPSTREAM FACE OF DAM FROM RIGHT ABUTMENT. SPILLWAY
IN FOREGROUND.
